Dynamic Video Survey Log Example With Field Notes Jan.31-Feb.01, 2008

Ascending from Bottom of Well (1239' bgs.)
To Bottom of Suction Cone (415' bgs.)

Inspector(s): Nate Bogie, Mehrdad Hejazian and Sara Pile

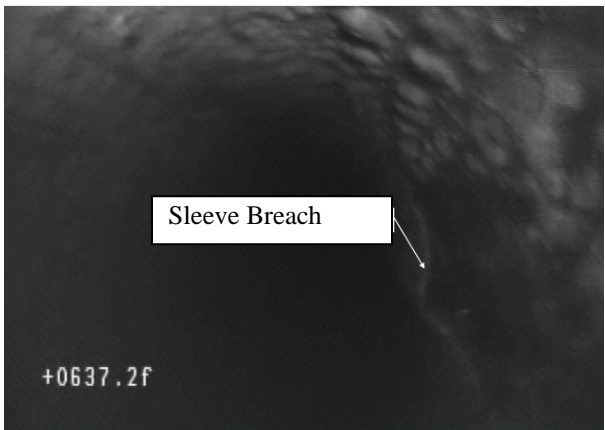
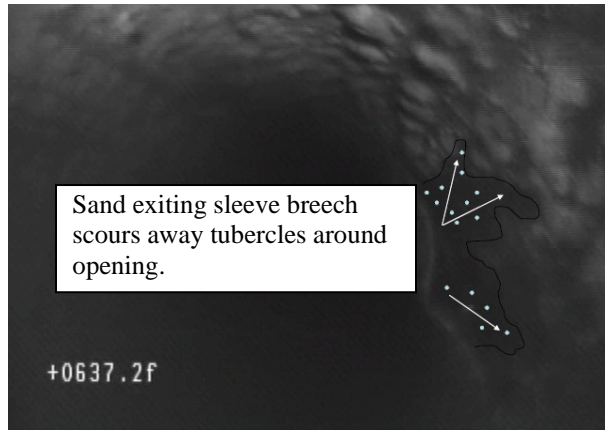
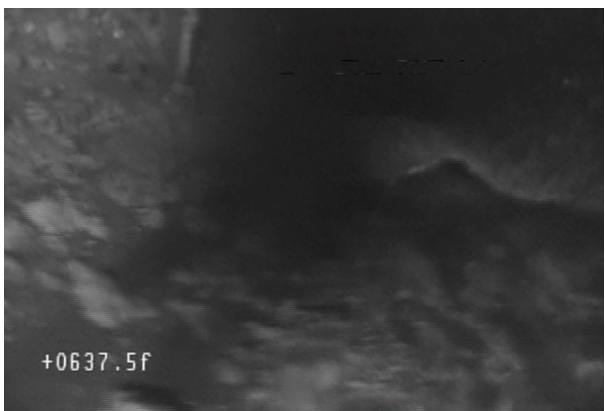
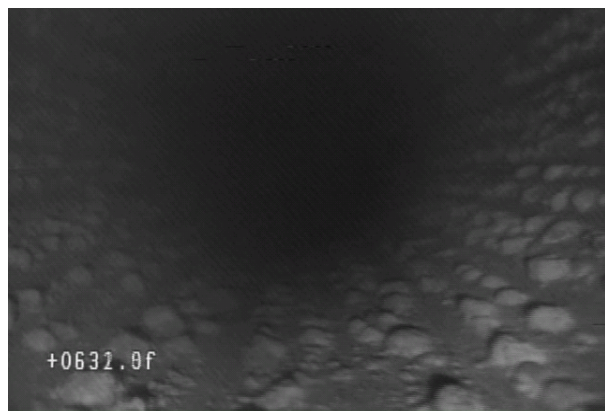
particles rising		
	640'	Large particles sinking		
	638'	Heavy turbulence, patch over old screen (600'-650') is damaged, camera moving violently		00:58:35
	637'	Turbulence decreases as camera ascends past damaged patch area		
	640'	Turbulence decreases as camera descends back to 640 feet		00:59:19
Disc #3 1/31/08	640'-635'	Ascending and descending to get a close look at damaged patch		
	636.6'	Camera starts to move violently, visibility obscured by sediment	1290 GPM	1:16:15
	637.8'	Cloud of sediment visible coming from side of well		1:21:05
	642.8'	Descended past turbulence and sediment		1:22:45
	643.4'	Reduced pumping rate	710 GPM	~1:25:00
	630'	Turbulence decreasing, still cloudy with sediment		
	610'	Water gradually clearing		
	532'	Rising particles, good visibility		
	415'	Suction cone visible
