Besst Inc. Video Survey Overview

Video Capabilities: Monitoring and Water Supply Wells

Besst Dynamic Video Survey used to pinpoint sand production:

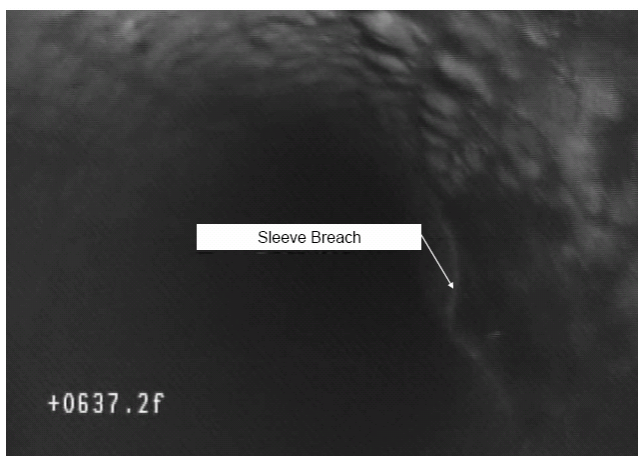
1. Video camera was inserted into the well between the pump column and the borehole while the pump was off.
2. The camera was slowly lowered from ground surface to the bottom and the entire borehole was inspected for damage while pump was off.
3. Once the entire borehole was surveyed in static environment and the camera was at the bottom of the well the pump was turned on to 1300 gpm.
4. The initial pulse of water when the pump started dislodged some buildup on the sides of the well casing and visibility was very low. After a couple of minutes of pumping at 1300 gpm the flow was reduced to 760 gpm and the visibility increased greatly. The borehole was surveyed for damage and sand production while the pump ran.
5. At 638 feet BGS there was a damaged sleeve over a screen that allowed sediment to enter into borehole. (see image 1)

6. After the initial diagnosis of the damaged patch the zone at 638 feet BGS it was surveyed going up and down at varying pumping rates (760, 1000, 1300 gpm) At different flow rates the amount of turbulence the camera experienced and the amount of sand the zone produced fluctuated drastically.
7. After the damaged area was surveyed closely the video survey continued to the bottom of the pump column. The pump was turned off as the camera ascended through the zone containing the suction tube, strainer, and pump bowls at 350' BGS.
8. Once the camera was above the pump bowls , the pump was turned back on to survey the upper screened portion of the well, and no significant damage was found.
